JULY 1967
REPORT SM-49105-F1

STRESS CORROSION CRACKING OF TITANIUM ALLOYS AT AMBIENT TEMPERATURE IN AQUEOUS SOLUTIONS

YEARLY SUMMARY REPORT
JULY 1966 THROUGH JUNE 1967
UNDER CONTRACT NAS 7-488

MISSILE & SPACE SYSTEMS DIVISION
DOUGLAS AIRCRAFT COMPANY, INC.
SANTA MONICA/CALIFORNIA

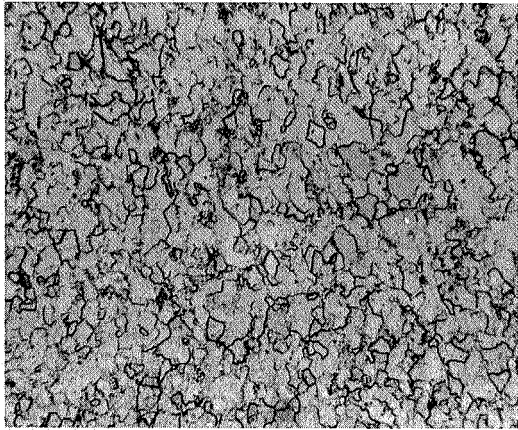
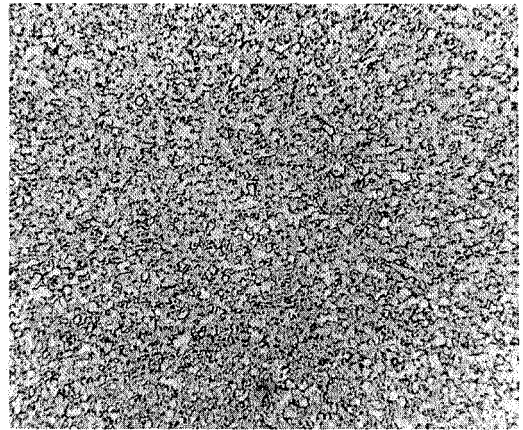
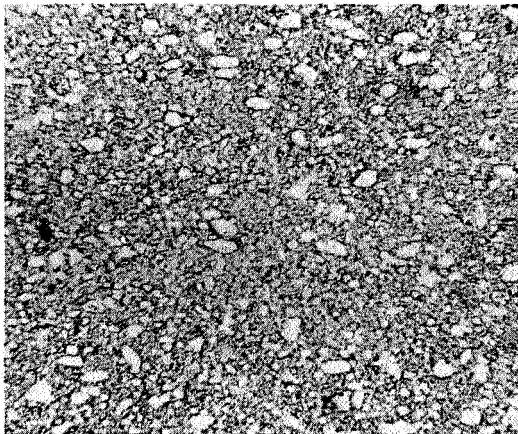
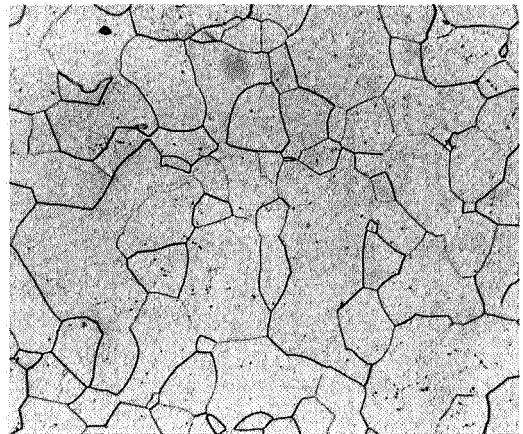
- a. Ti-5Al-2.5Sn
- b. Ti-6Al-4V
- c. Ti-8Al-1Mo-1V
- d. Ti-13V-11Cr-3Al

Figure 1. Microstructure of Titanium Alloys, Mag. 200X

The microstructure of each alloy is shown in Figures 1a, 1b, 1c and 1d. Only the beta alloy, Ti-13V-11Cr-3Al, showed a coarse grain structure. The microstructure of the two alpha-beta alloys, Ti-8Al-1Mo-1V and Ti-6Al-4V, exhibited a continuous alpha matrix.

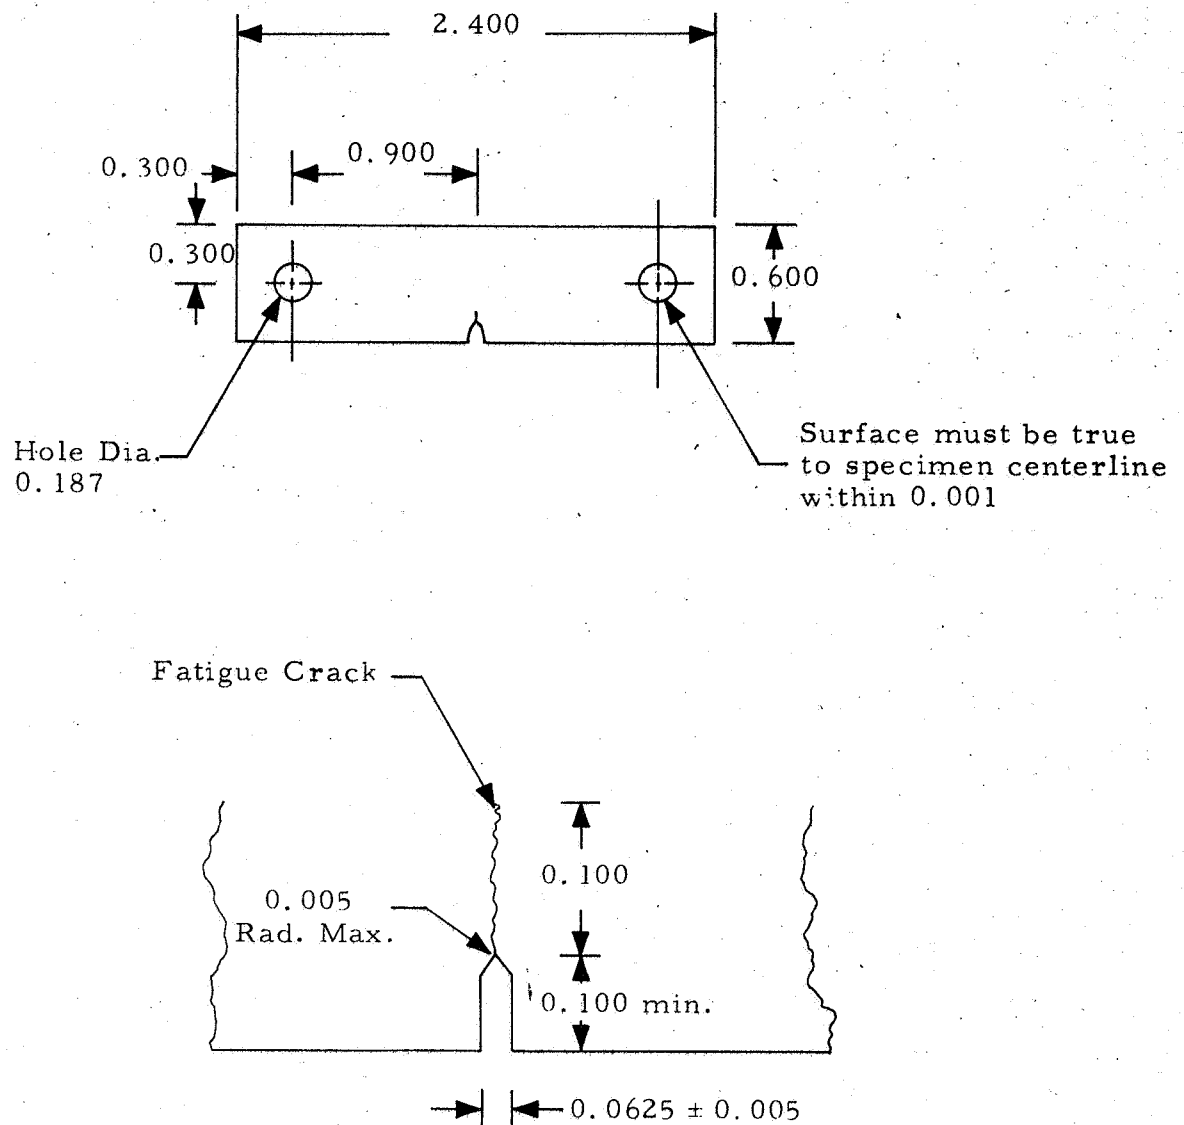
Figure 2. Stress Corrosion Specimen Configuration For 0.075 in. Thick Titanium Alloys Ti-5Al-2.5Sn, Ti-6Al-4V, and Ti-13V-11Cr-3Al

On the basis of the $B = 0.65 \left(\frac{K_{Ic}}{\sigma_{ys}} \right)^2$ minimums, sheets of Ti-6Al-4V and Ti-13V-11Cr-3Al of thickness 0.075", and sheets of Ti-8Al-1Mo-1V of thickness 0.109" were chosen. Ti-5Al-2.5Sn sheet of 0.075" was also chosen even though it was recognized that plane stress conditions were not met. Plates of 0.525" are too large to test in available apparatus.

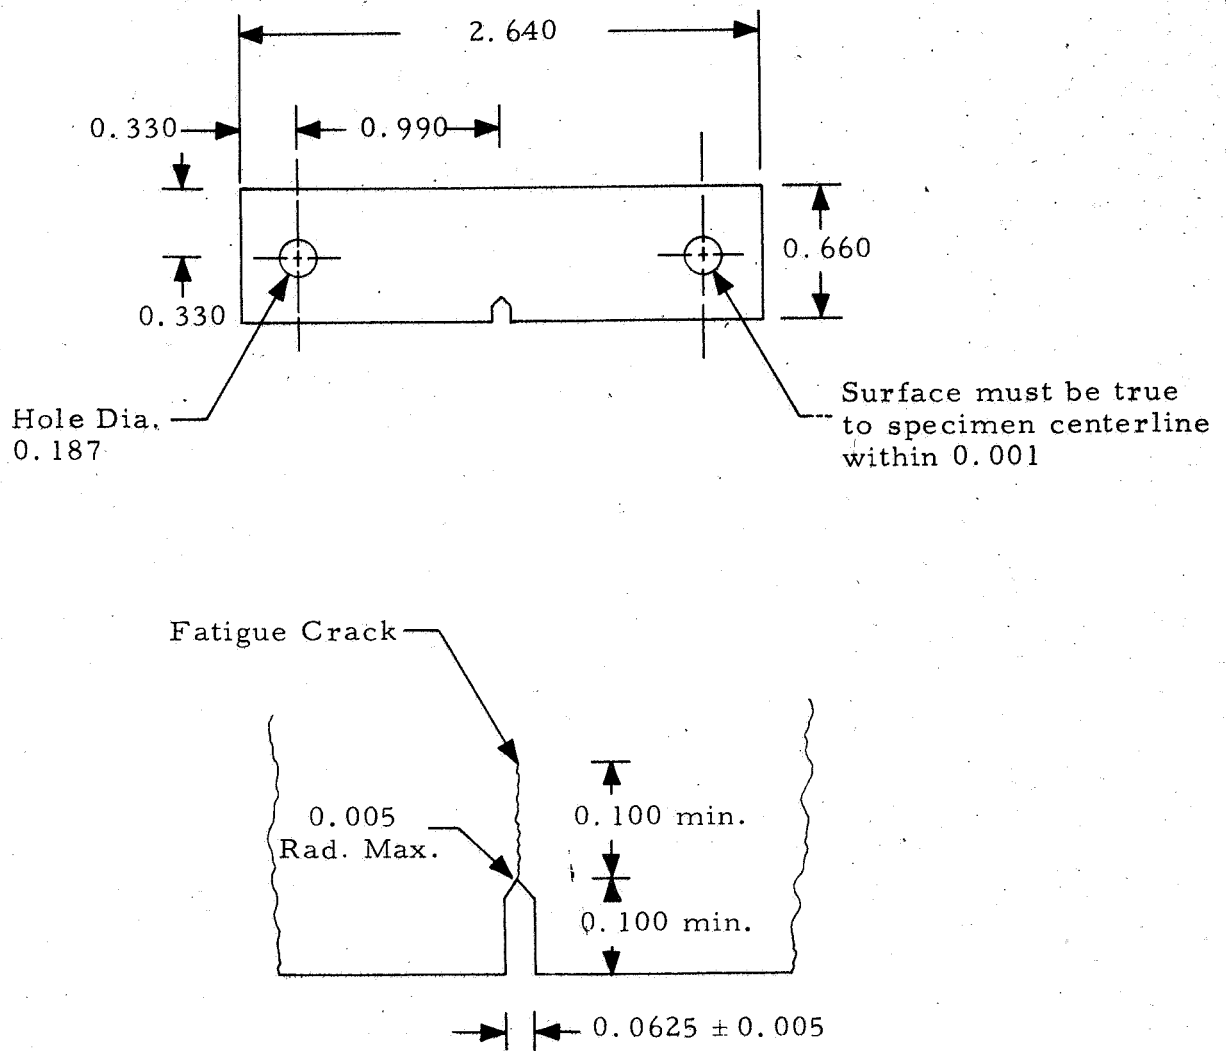
Figure 3. Stress Corrosion Specimen Configuration For 0.109 in. Thick Titanium Alloy, Ti-8Al-1Mo-1V

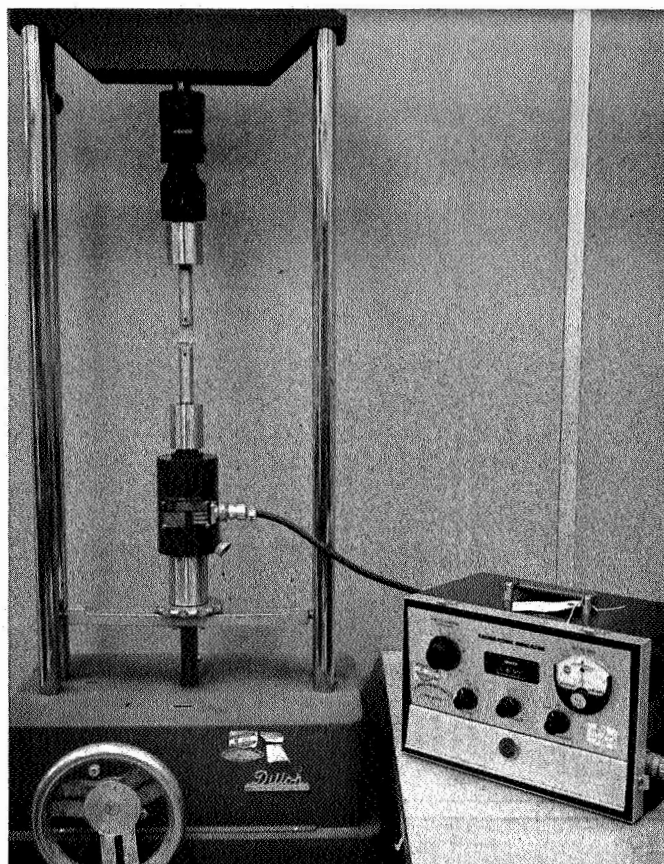
Figure 4. Stress Corrosion Apparatus

Stress corrosion tests were conducted by loading the single-edge-notched specimen in a Dillon tensile machine shown in Figure 4. The load was measured with a Baldwin-Lima-Hamilton SR-4 Load Cell which is capable of measuring the total load within four pounds. The corrosion solution is contained in a lucite box sealed to the specimen with an epoxy to prevent leakage. Distilled water and 3% NaCl solution at ambient temperature were the corrosion solutions used in the program. Crack extension was observed with a stereo-microscope.

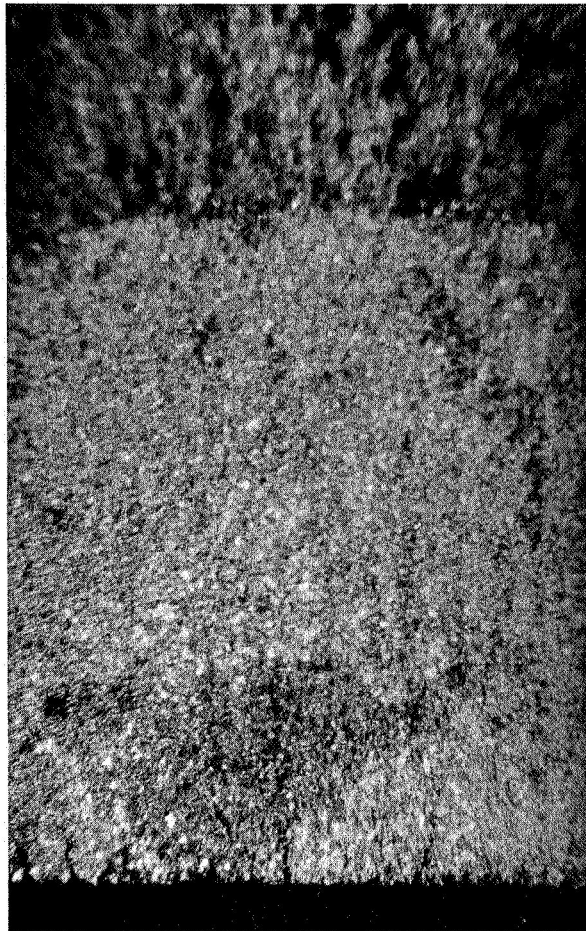
- ← Plane Strain Fracture
- ← End of Fatigue Fracture
- ← Fatigue Fracture
- ← Start of Fatigue Fracture

Figure 5. Fracture Surface of Ti-8Al-1Mo-1V. Mag. 40X.

For each specimen, the initial crack length, a, was measured with a low power microscope following fracture of the specimen, and was used to calculate K_c . Figure 5 shows a typical fatigue crack.

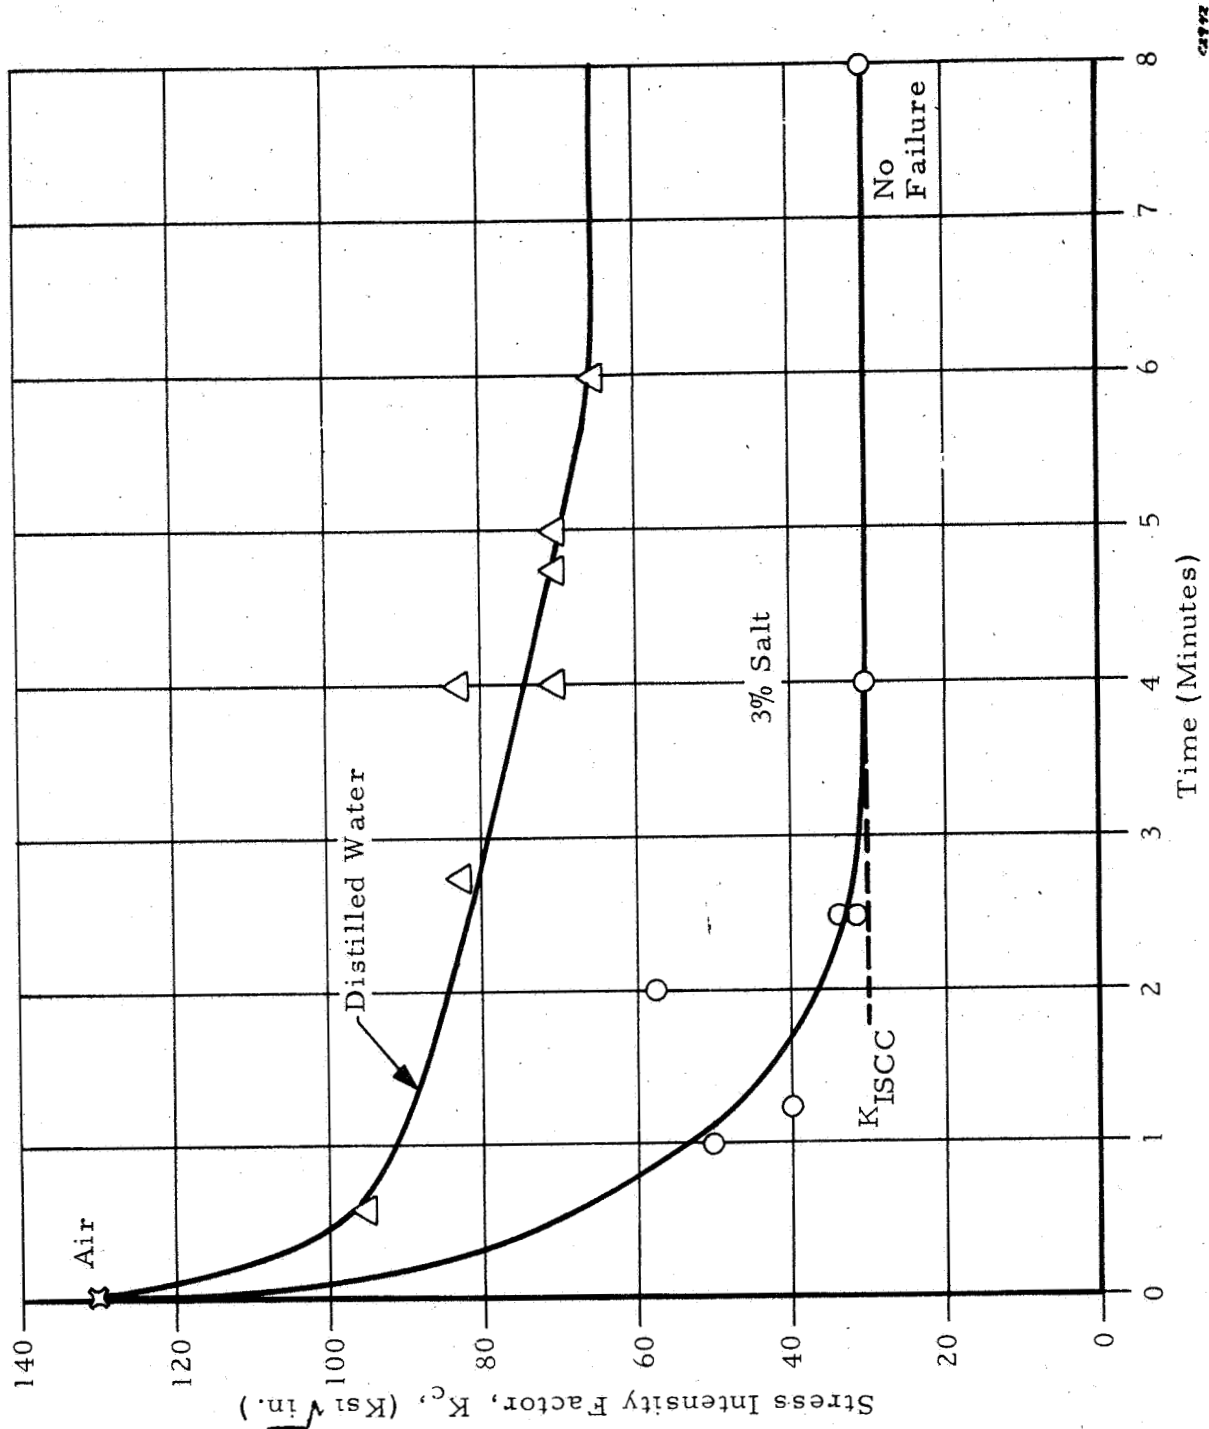
Figure 6. Effect of Initial Stress Intensity on Time-To-Fracture for Ti-5Al-2.5Sn at Ambient Temperature

This value, K_c , was then plotted versus the time for fracture in Figures 6, 7, 8, and 9. An examination of the graphs shows that there was a minimum value of K_c below which no stress corrosion failure is observed. This is designated K_{ISCC} after Brown.⁽²⁰⁾

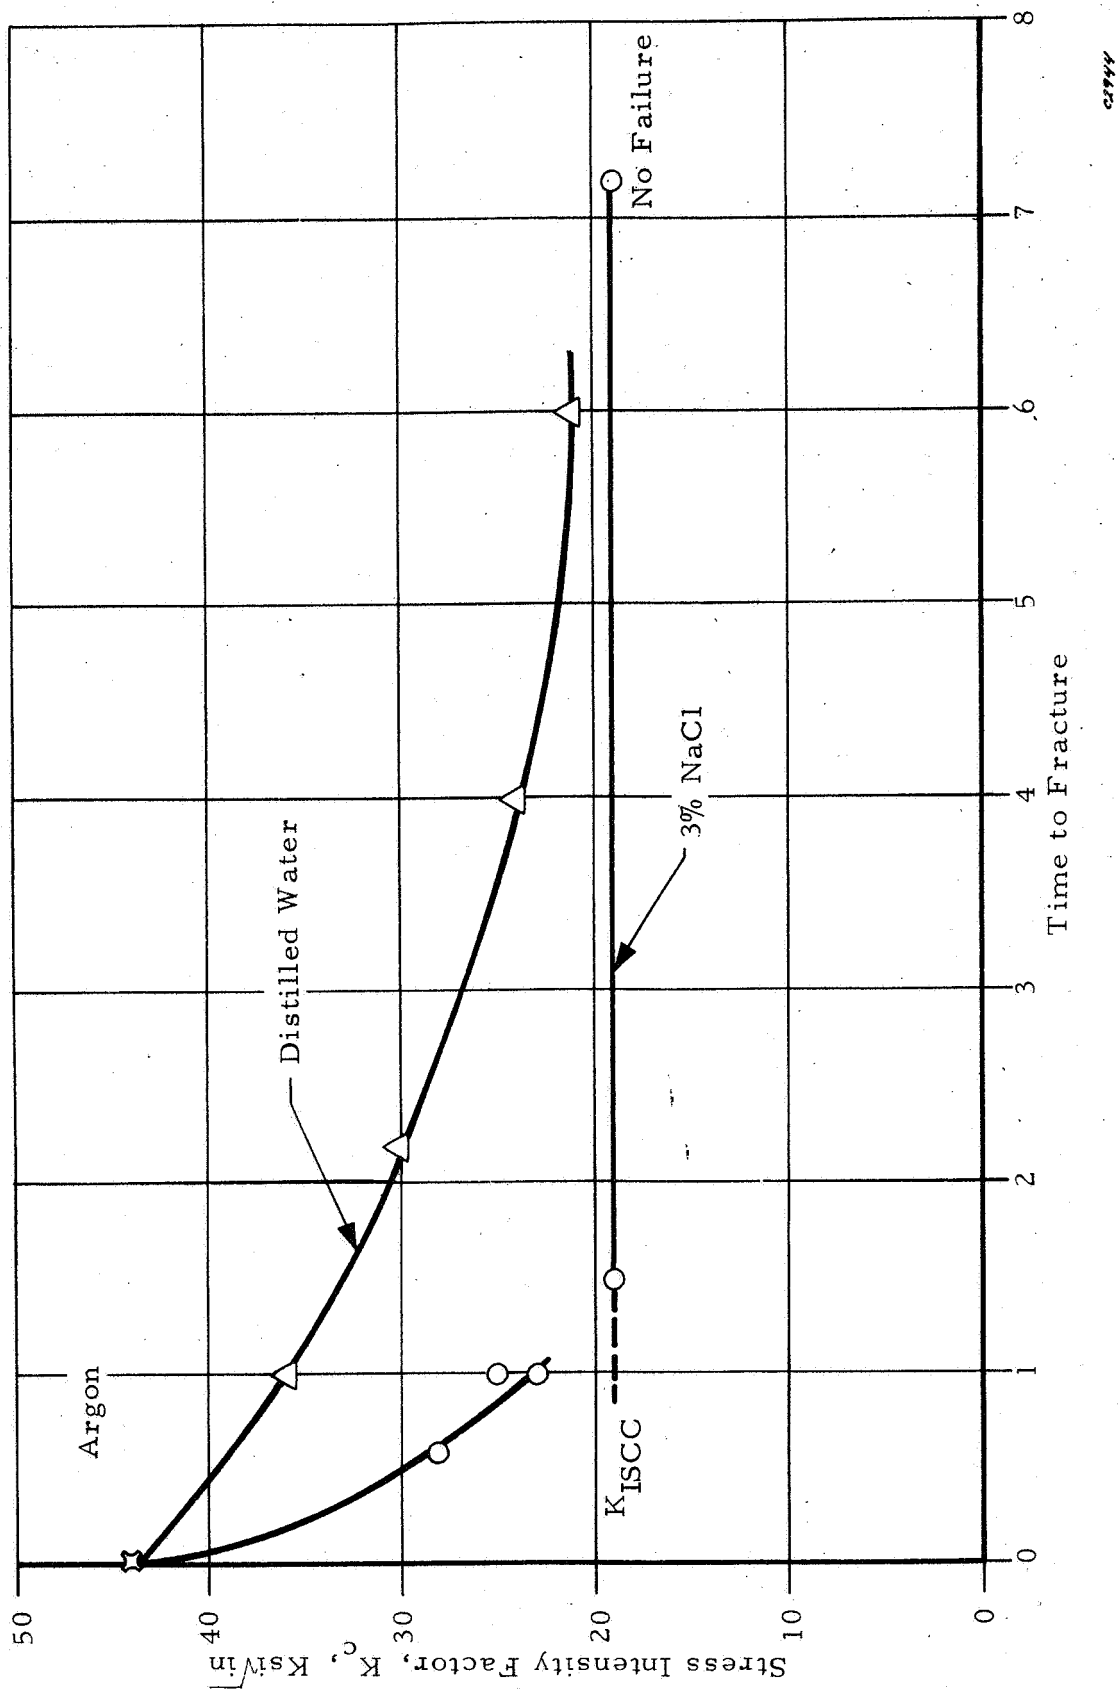
Figure 7. Effect of Initial Stress Intensity on Time-to-Fracture for Ti-8Al-1Mo-1Ti at Ambient Temperature

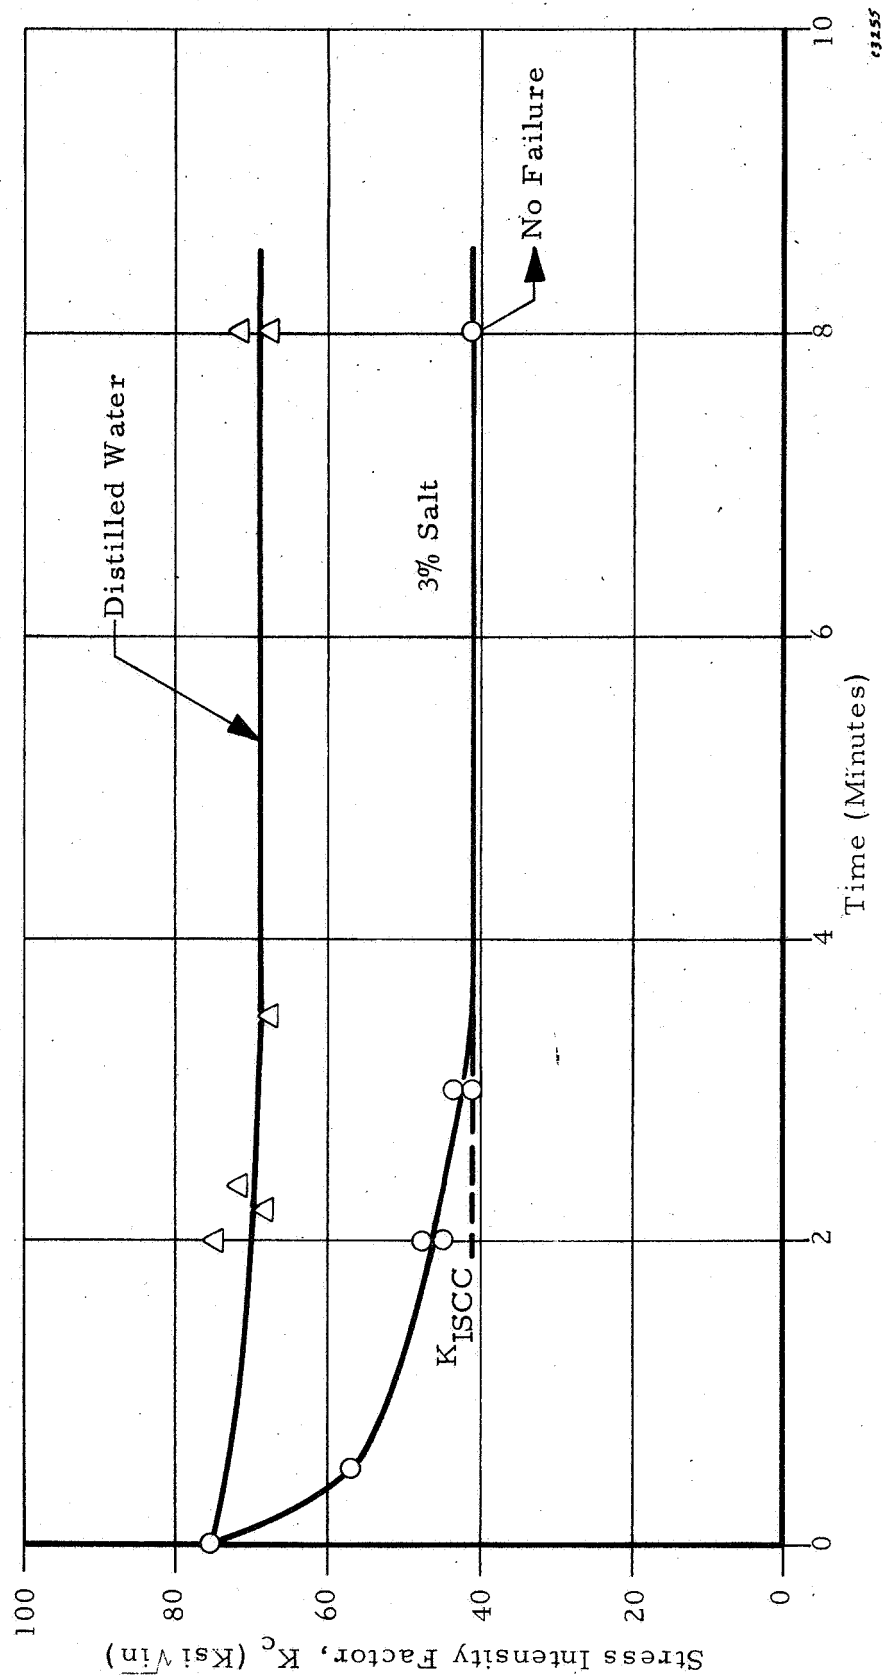
Figure 8. Effect of Initial Stress Intensity on Time-To-Fracture For Ti-6Al-4V at Ambient Temperature

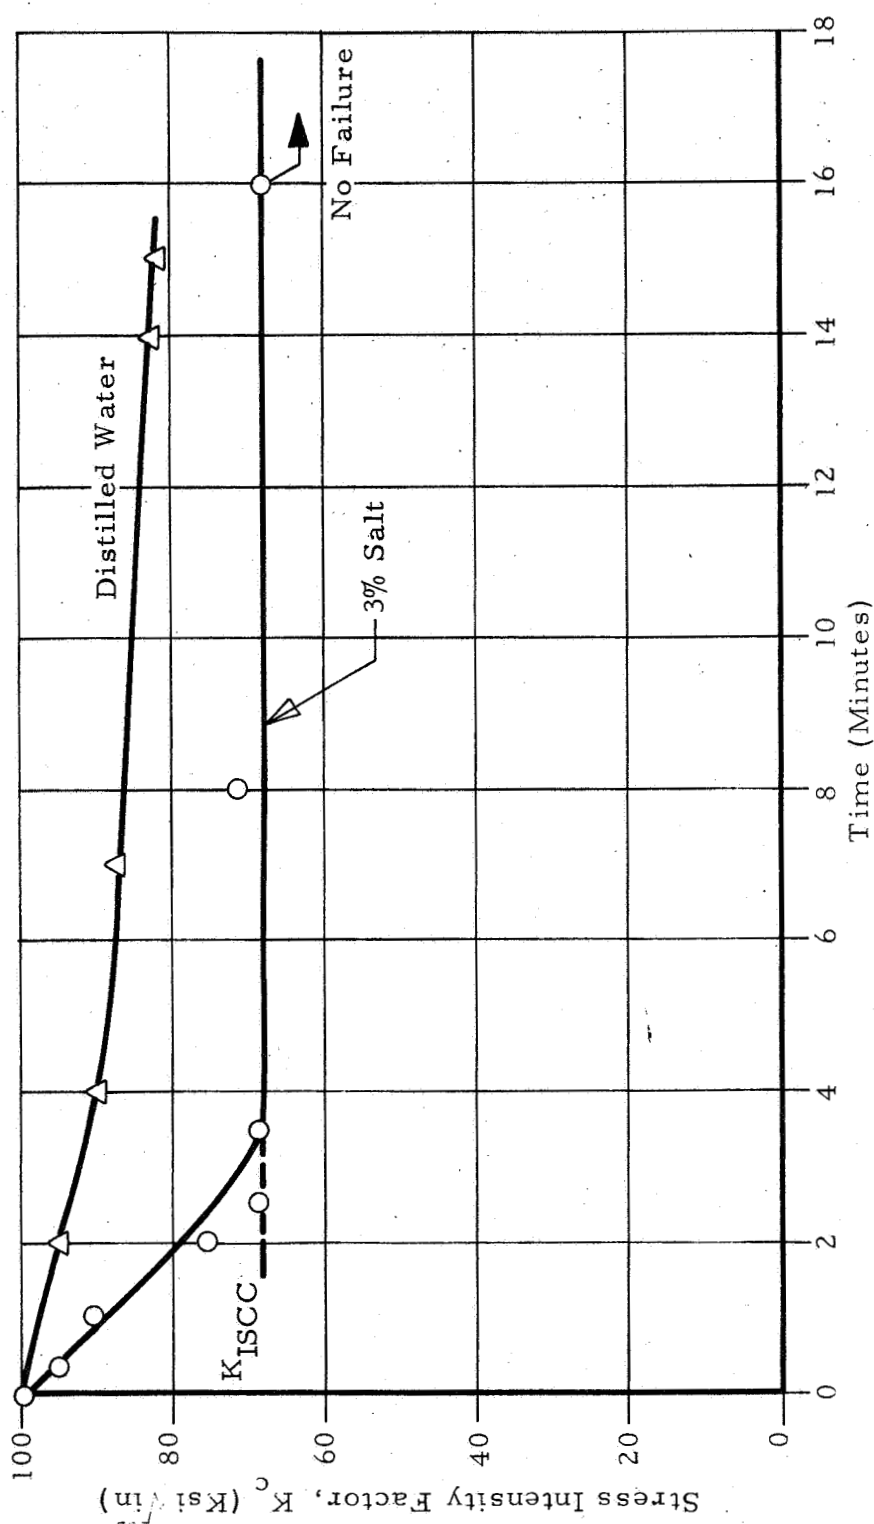
Figure 9. Effect of Initial Stress Intensity on Time-To-Fracture For Ti-13V-11Cr-3Al

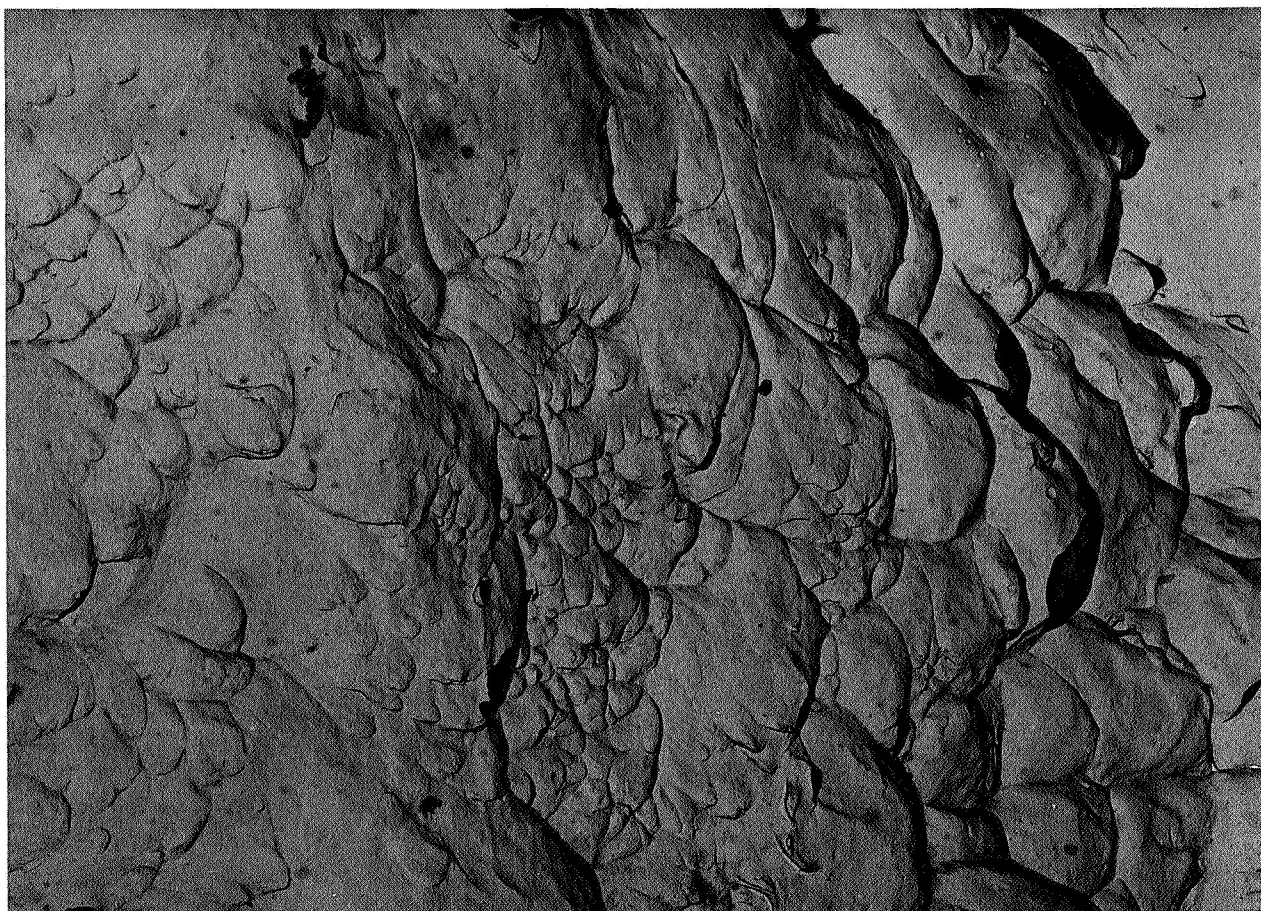
Figure 10. Electron Fractograph of Beta Alloy Ti-13V-11Cr-3Al
Fractured in Air. Note dimple rupture.
Magnification 7,500X

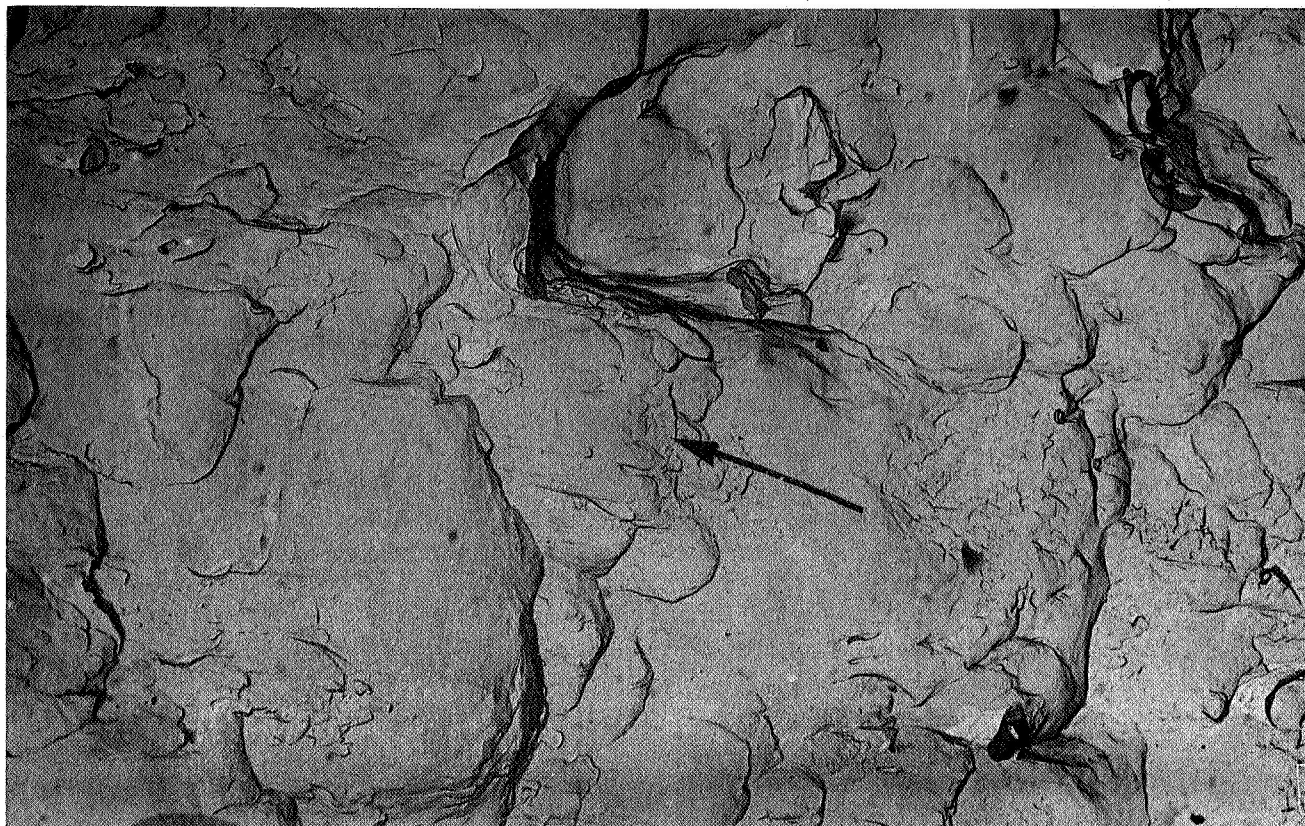
Figure 11. Electron Fractograph of an Alpha-Beta Alloy Ti-6Al-4V Fractured in Air. Note dimple rupture. Magnification 7,500X

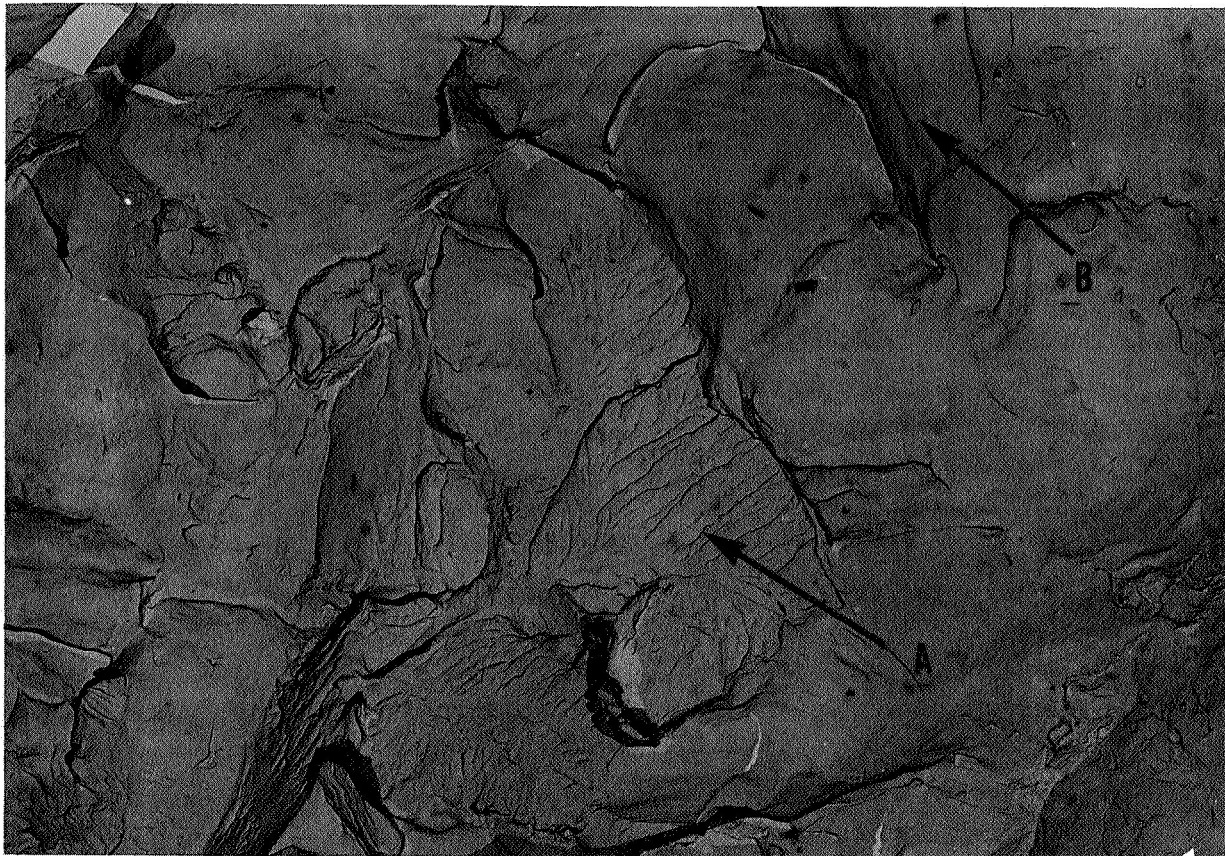
Figure 12. Electron Fractograph of Stress Corrosion Region of Ti-6Al-4V Fractured in 3% Salt Solution. Fractograph shows a mixture of cleavage (Arrow A) and ductile failure (Arrow B). Magnification 7,500X

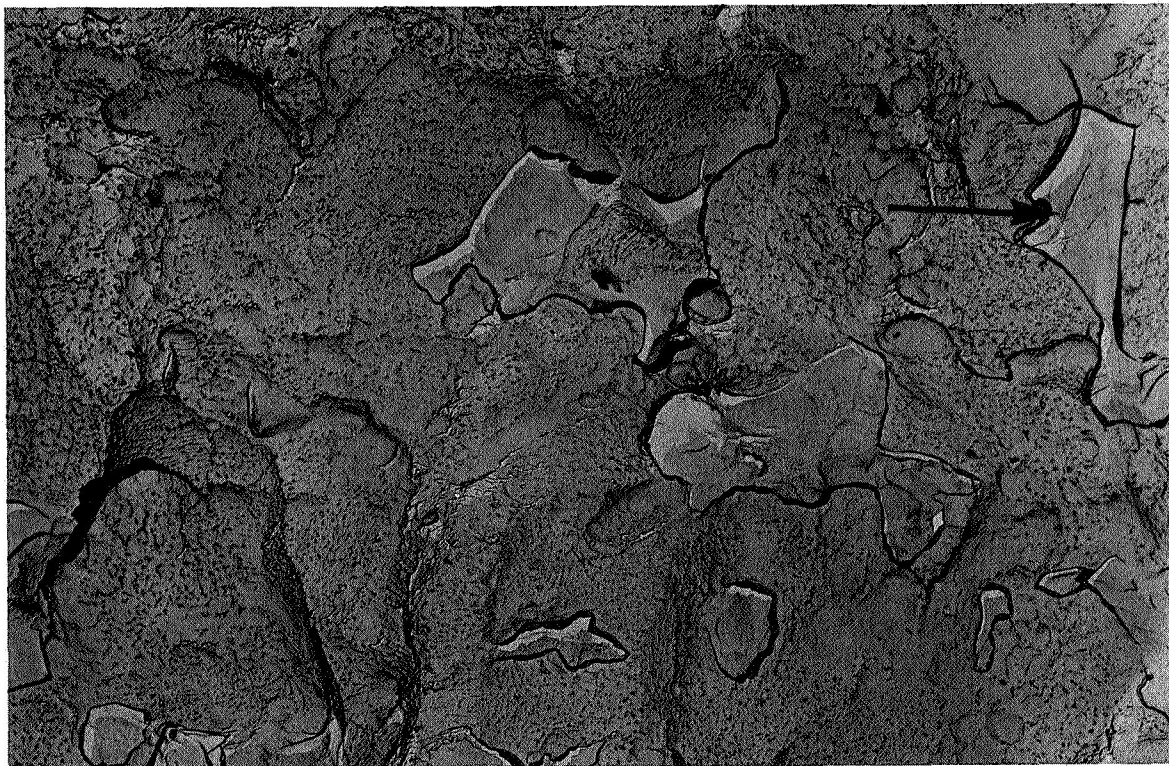
Figure 13. Electron Fractograph of Stress Corrosion Region of Ti-6Al-4V Fractured in 3% Salt Solution. Fracture has been etched for 15 seconds in HF-HNO₃-H₂O solution. Arrow points to beta phase exhibiting cleavage markings. Magnification 7,500X.

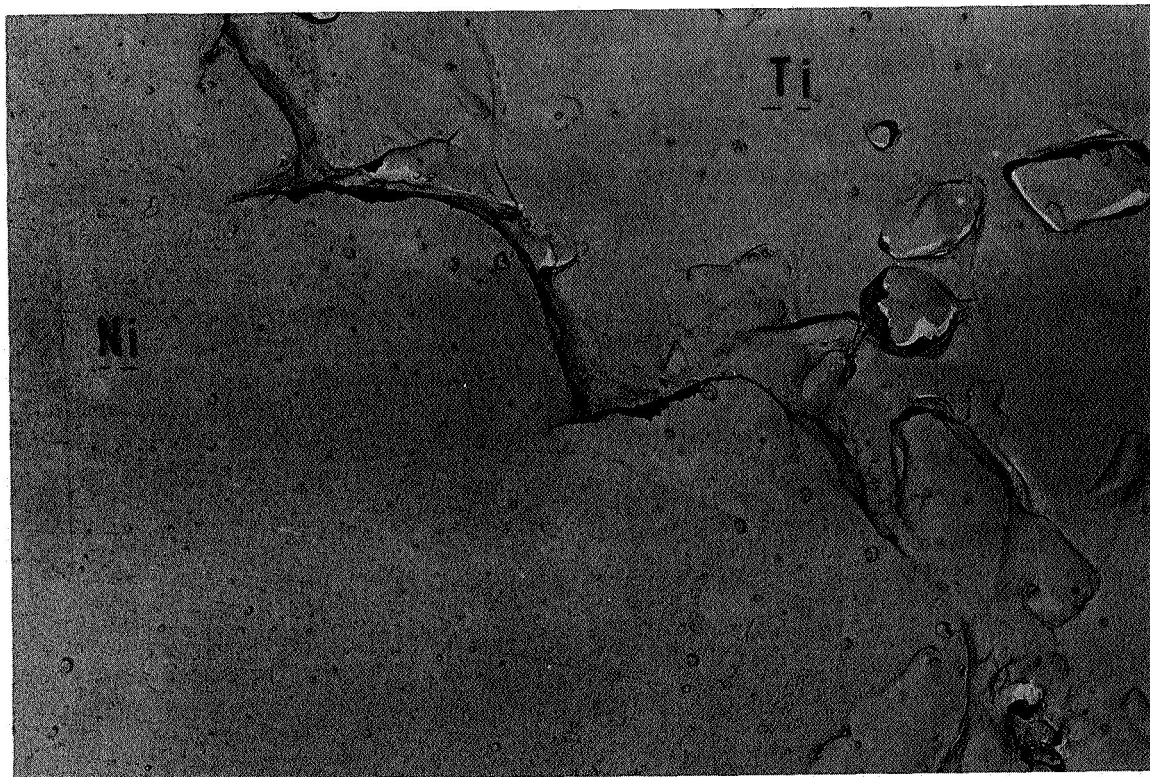
Figure 14. Profile of Fracture Edge of Ti-6Al-4V Fractured in Air. Micrograph shows transgranular ductile rupture. Magnification 7,500X.

Profile cross sections of the fracture edge were made of the Ti-6Al-4V alloy failed in air and in salt solution. The fracture in air (Figure 14) indicated transgranular ductile rupture and distortion of alpha. The fracture in salt solution (Figure 15) indicated that the crack path appears to follow alpha-beta phase boundary by cleavage, and rupture is possibly not taking

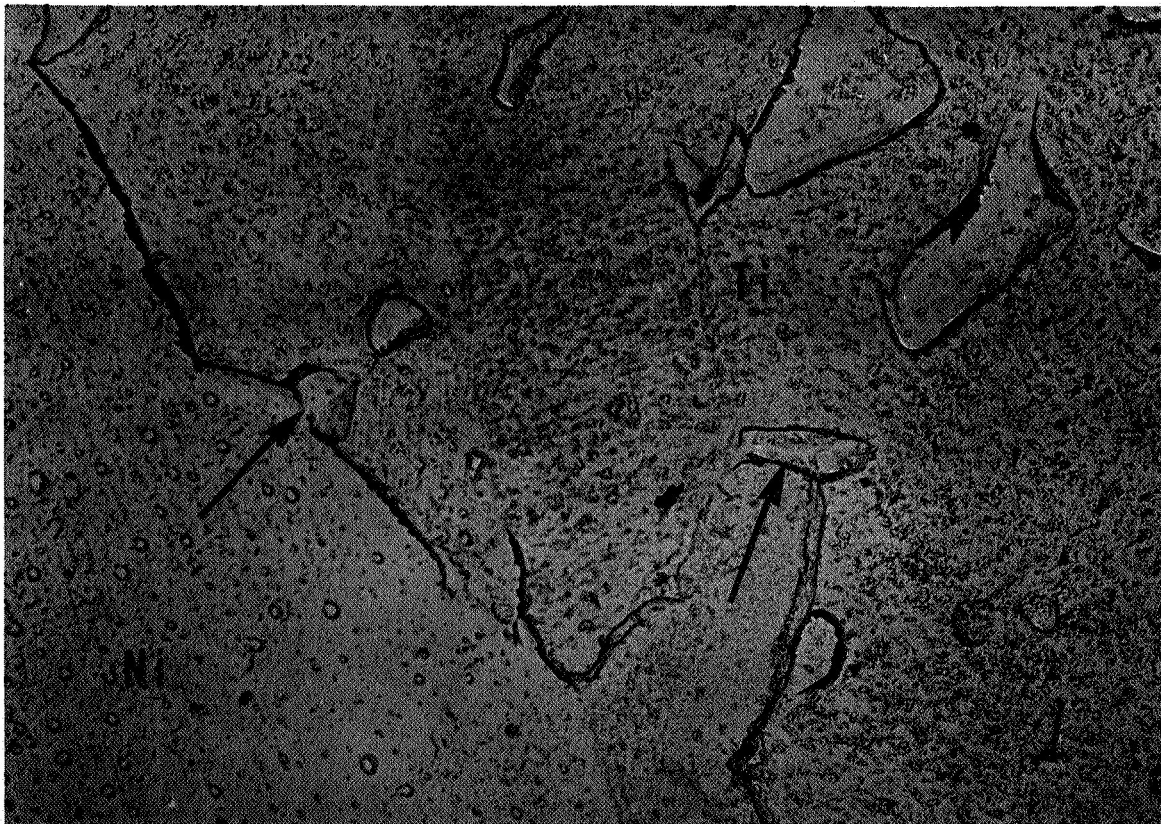
Figure 15. Profile of Fracture Edge from Stress Corrosion Region of Ti-6Al-4V Fractured in 3% NaCl Solution. Fracture propagated along an alpha-beta boundary by cleavage (Arrows). Magnification 7,500X.

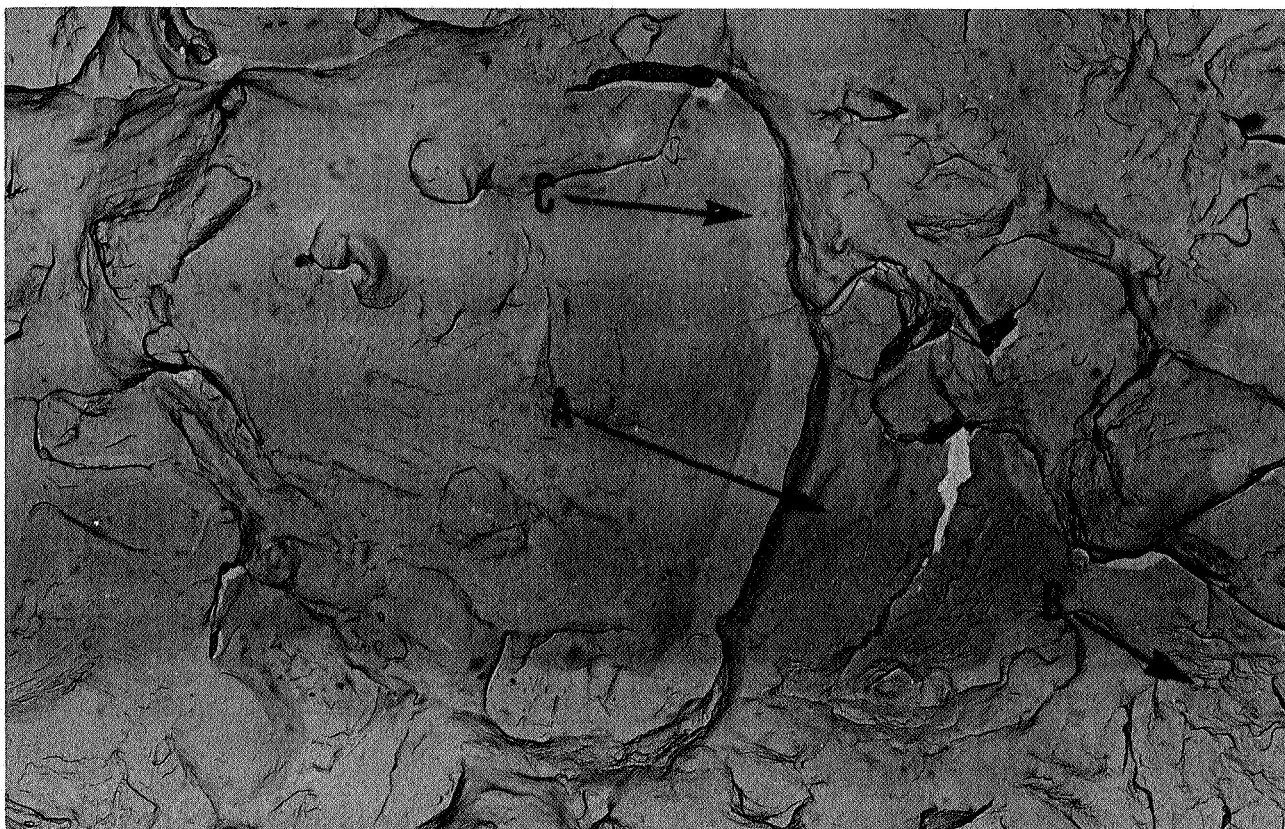
Figure 16. Electron Fractograph from Stress Corrosion Region of Ti-8Al-1Mo-1V Fractured in 3% Salt Solution. Fractograph shows ductile rupture (Arrow A), cleavage (Arrow B) and evidence of intergranular fracture (Arrow C). Magnification 7,500X.

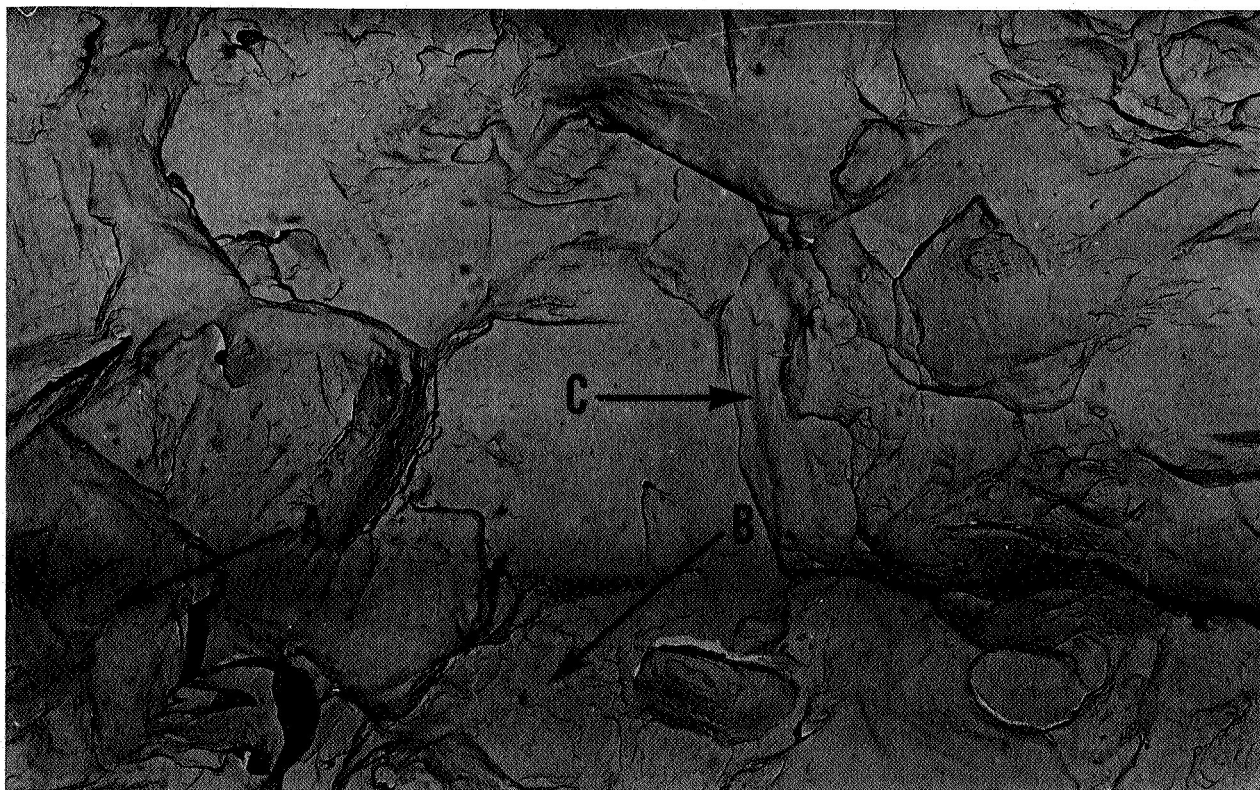
Figure 17. Electron Fractograph from Stress Corrosion Region of Ti-8Al-1Mo-1V Fractured in Distilled Water. Fractograph shows ductile rupture (Arrow A), cleavage (Arrow B), and evidence of intergranular fracture (Arrow C). Magnification 7,500X.

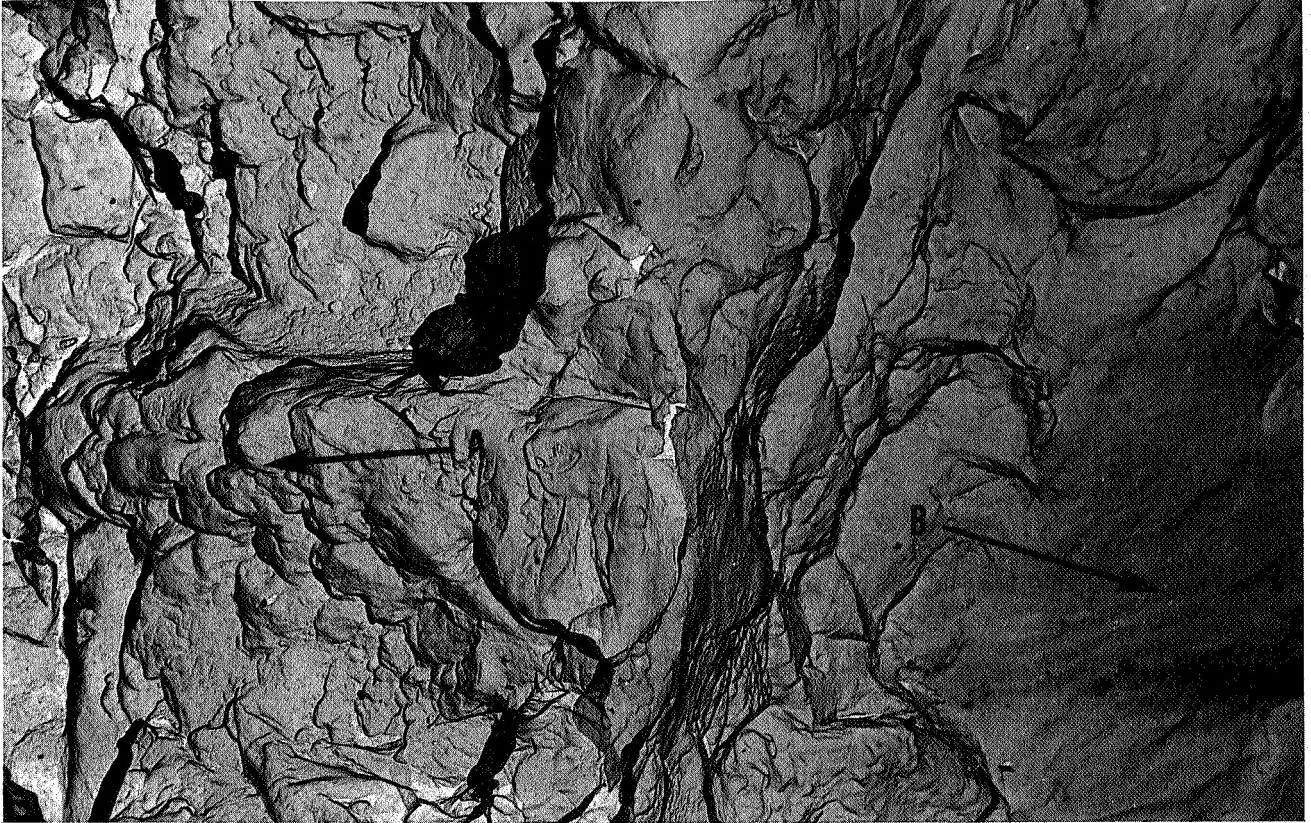
Figure 18. Electron Fractograph of Air Fractured Surface of Ti-5Al-2.5Sn. Fractograph shows dimple rupture (Arrow A), and glide characteristic of ductile fracture (Arrow B). Magnification 7,500X.

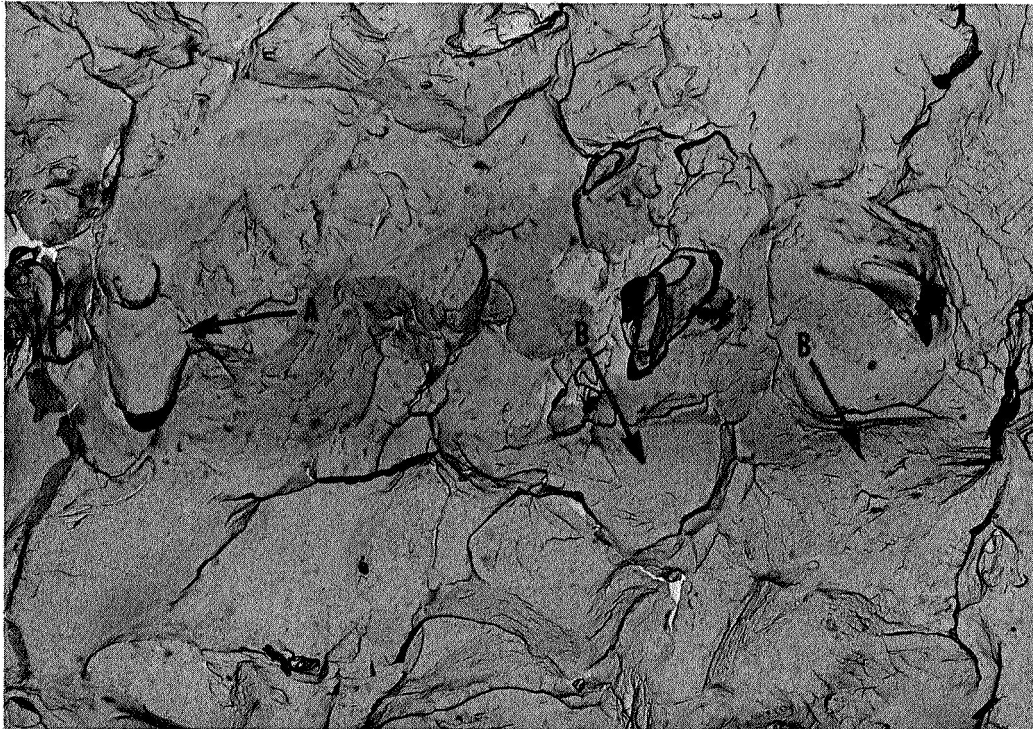
Figure 19. Electron Fractograph from Stress Corrosion Region of Ti-5Al-2.5Sn Fractured in 3% NaCl. Fractograph shows cleavage area (Arrow A). Most of the fracture exhibits ductile failure with these local cleavage areas distributed throughout. Magnification 7,500X.
